## IED Report

BLAST-  
TRACKING NUMBER: 20111114092038SNA0132  
647260

**TITLE:** (EXPLOSIVE HAZARD) IED EXPLOSION RPT (Directional IED) 2/B/2-8 CAV, 1-1 CAV IVO (ROUTE MSR TAMPA): 0 INJ/DAM

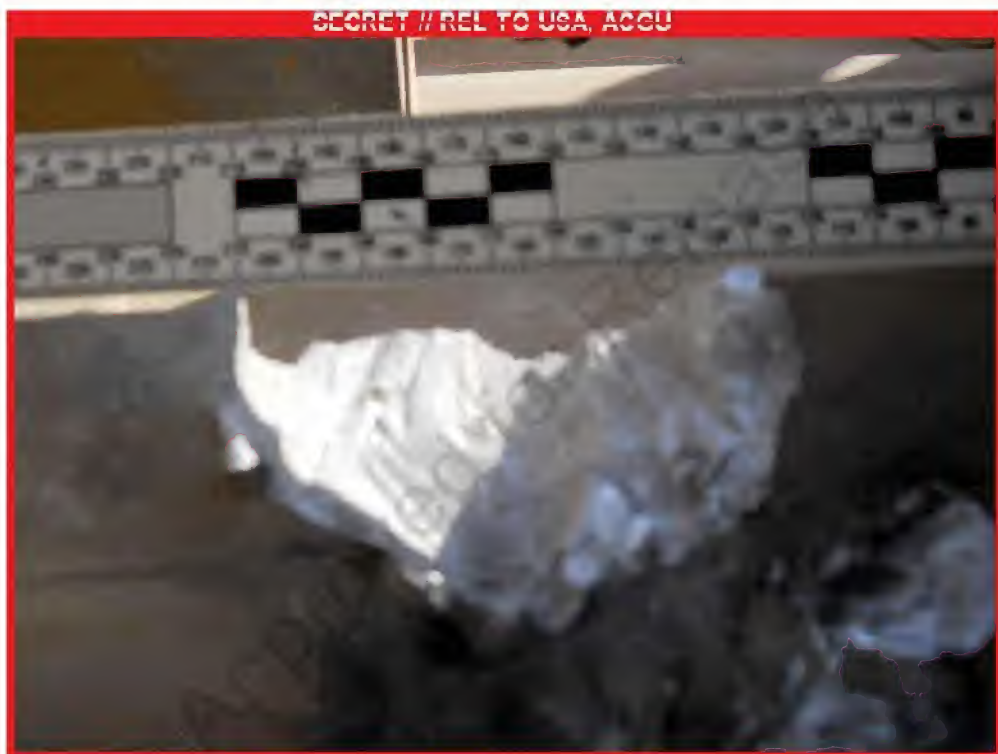
OTHER EFP IMPACT POINT WITH SCALE

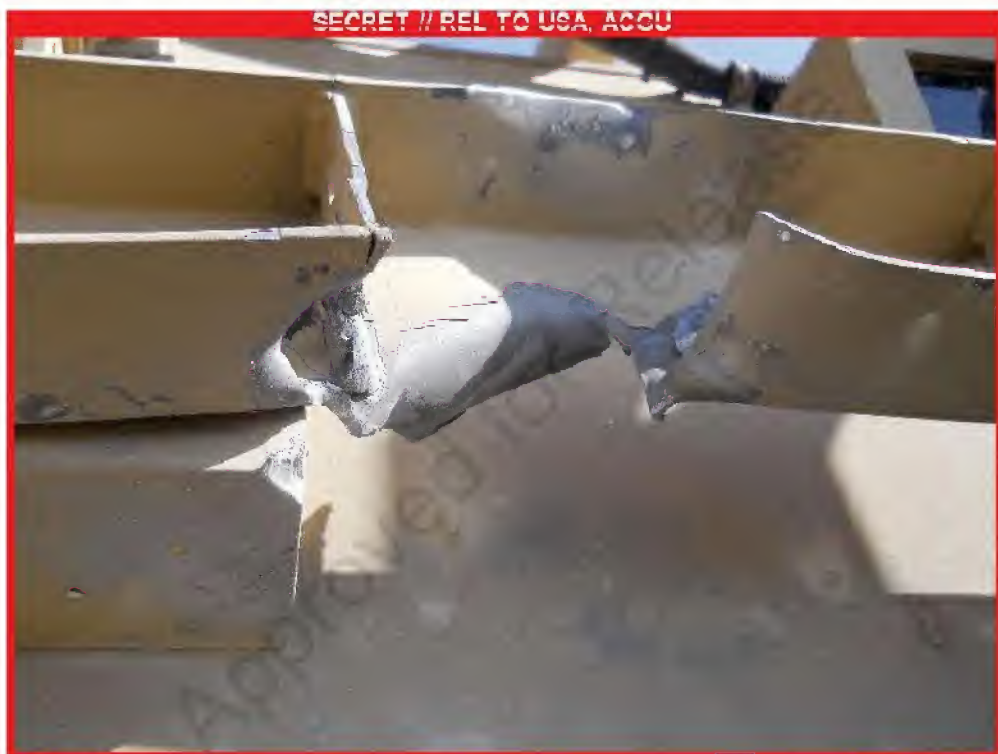
OTHER IMPACT AREA FROM EFP ON THE RIGHT SIDE REAR
